Coomera Connector Stage One (1): Public Environmental Report

Appendix 9: Helensvale Road vegetation survey (FRC 2022)

## **Coomera Connector:**

### **Assessment of Vegetation on the Southern Side of Helensvale Rd**

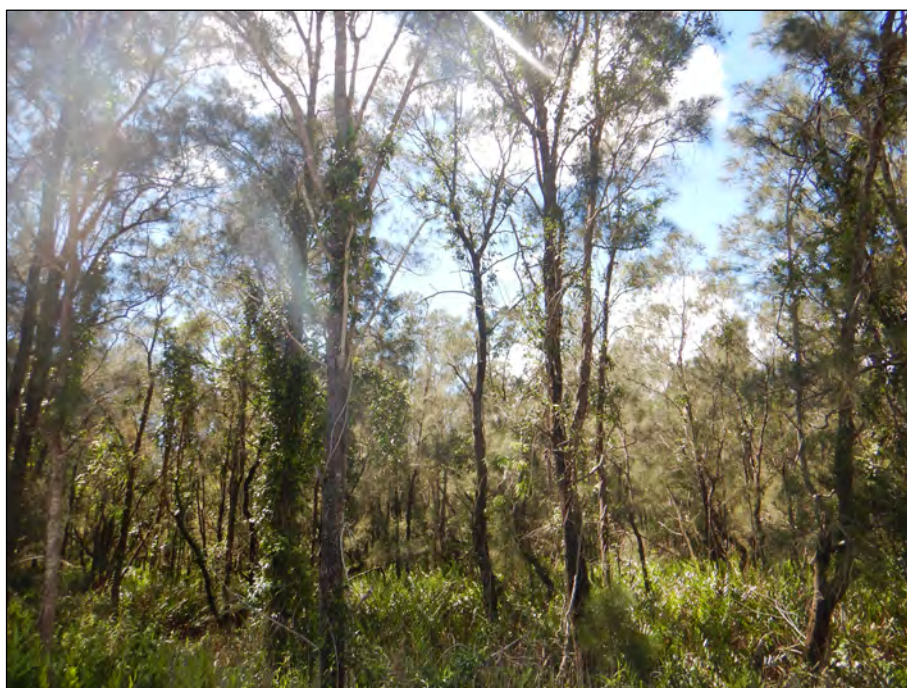
This community was dominated by *Casuarina glauca* (swamp she oak) trees to 12+ m high with a canopy cover of approximately 50 to 70 %, and with *Acrostichum speciosum* (mangrove fern) dominating the understory (Figure 4.1). There were also sparse, scattered trees of *Avicennia marina* (grey mangroves) approximately 8+ m high.

Figure 4.1 *Casuarina glauca* dominated community with *Acrostichum speciosum* understory.

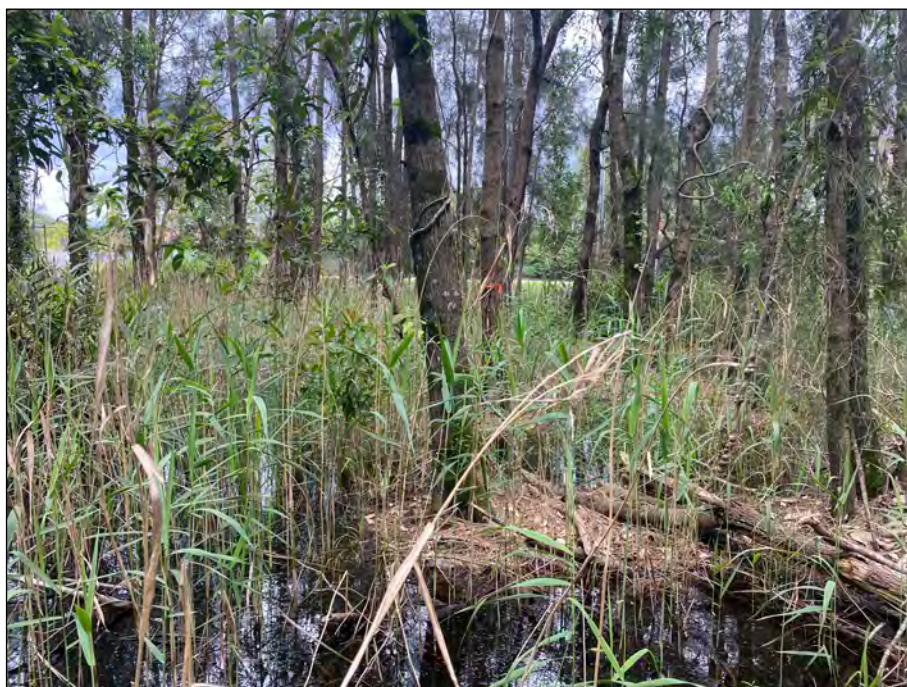
In this community, there were also patches of *Phragmites australis* (common reed) in the understory, near the road (Figure 4.2). In wet areas, *Juncus* sp., *Eclipta prostrata* (false daisy), *Eleocharis* sp. (water chestnut) and *Typha* sp. (bullrush) were present. Vines, including *Parsonsia straminea* (monkey pod vine), were common growing up the swamp she oak trees. On the edge of the forest near the road, there were also some sparse, scattered trees including, *Cupaniopsis anacardioides* (tuckeroo), *Livistona australis* (cabbage tree palm), *Syzygium smithii* (lilly pilly), *Melaleuca quinquenervia* (broad-leaf paperbark) and *Excoecaria aggallocha* (milky mangrove). Under the canopy on the roadside edge of the forest, there was a strip of weed dominated plants 1 – 3 m wide, including *Cyperaceae* sp., *Emilia sonchifolia* (tasselflower) and *Ludwigia octovalvis* (Mexican primrose-willow) (Figure 4.3). There were also scattered patches of *Sporobolus virginicus* (marine couch) in this strip.

Figure 4.2 *Casuarina glauca* dominated community with *Phragmites australis* in the understory.

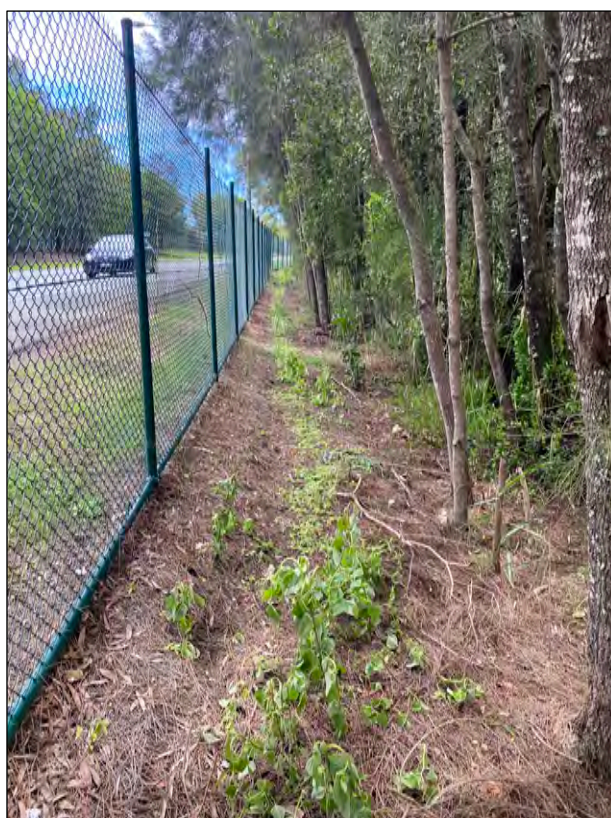
The landward edge of this community, from the fence line to approximately 10 m in, is highly disturbed, with introduced plants, a significant amount of litter, and ponding of water adjacent to the culverts. While there is less disturbance over 10 m from the road, there was still a considerable amount of litter. While the dominant plants were in good condition, ponding of water in this area may also negatively impact the medium to long term viability of this community.

Figure 4.3 Weeds near the road verge, beneath the *Casuarina glauca* canopy.

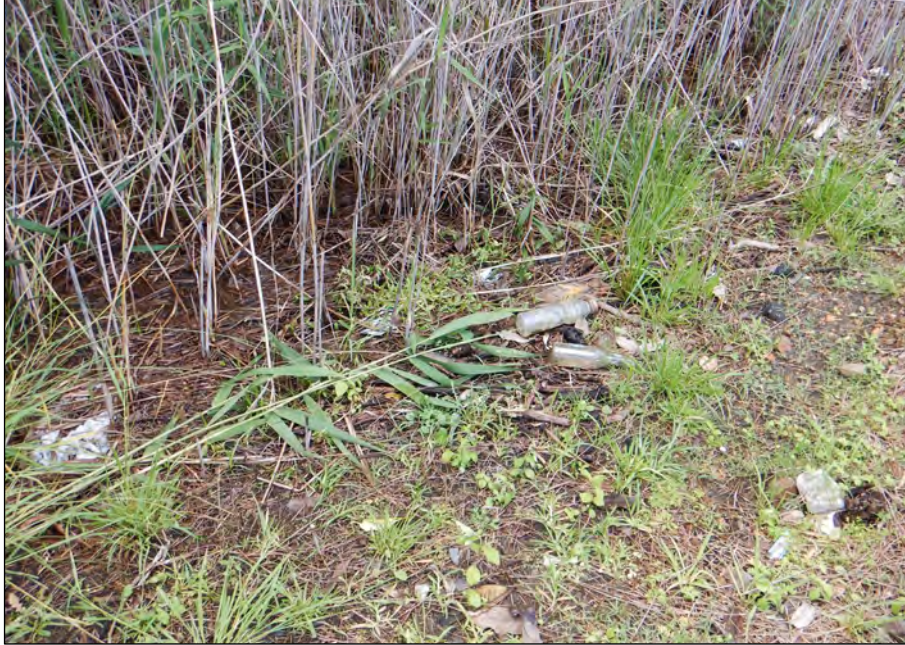
There was a significant amount of litter throughout this community, particularly close to the road (Figure 4.4).

Figure 4.4 Litter was common, particularly near the road verge.

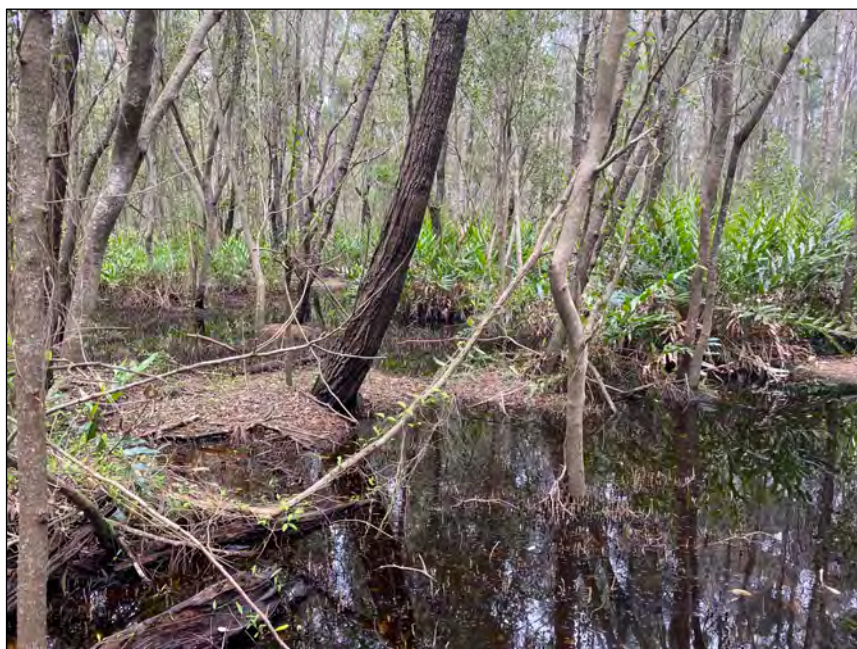
This community was dominated by grey mangroves approximately 8+ m tall, with an understorey dominated by mangrove ferns (Figure 4.5). Water was predominantly fresh in this area, with plants that are intolerant of highly saline water such as *Azolla* (duckweed), floating on the surface. Tidal flushing on the landward side of these mangroves is poor in this area – with little to no tidal movement recorded between low and high tide in June 2021. While the mangroves currently appear to be in good condition, the ponding and poor tidal exchange in this area may limit their long term viability.

Figure 4.5 *Avicennia marina* community with mangrove fern understory.

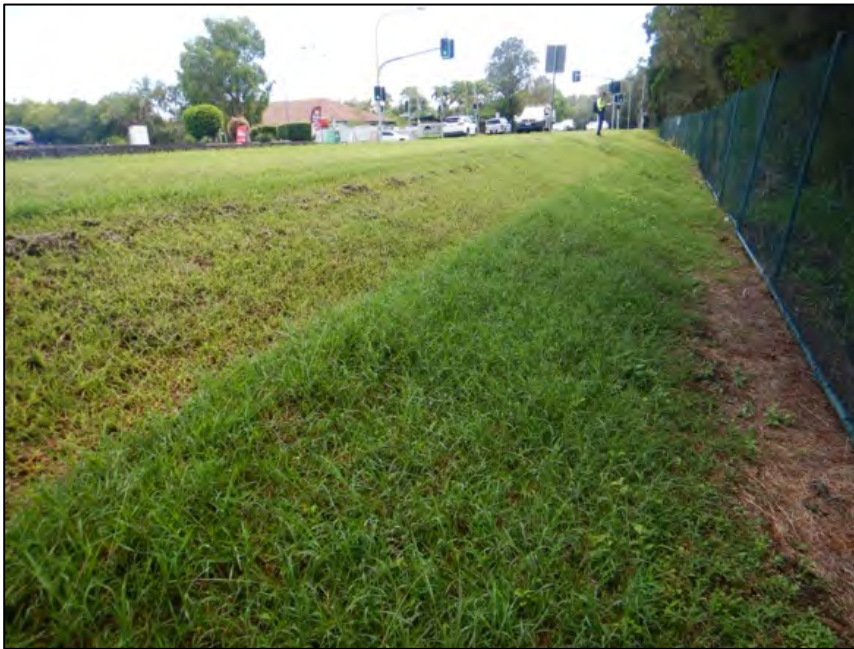
This community was approximately 4 m wide, and was along the road verge, between the road and the fence. It is regularly mown and is dominated by a variety of grasses (Figure 4.6).

Figure 4.6 Mown grass on road verge.

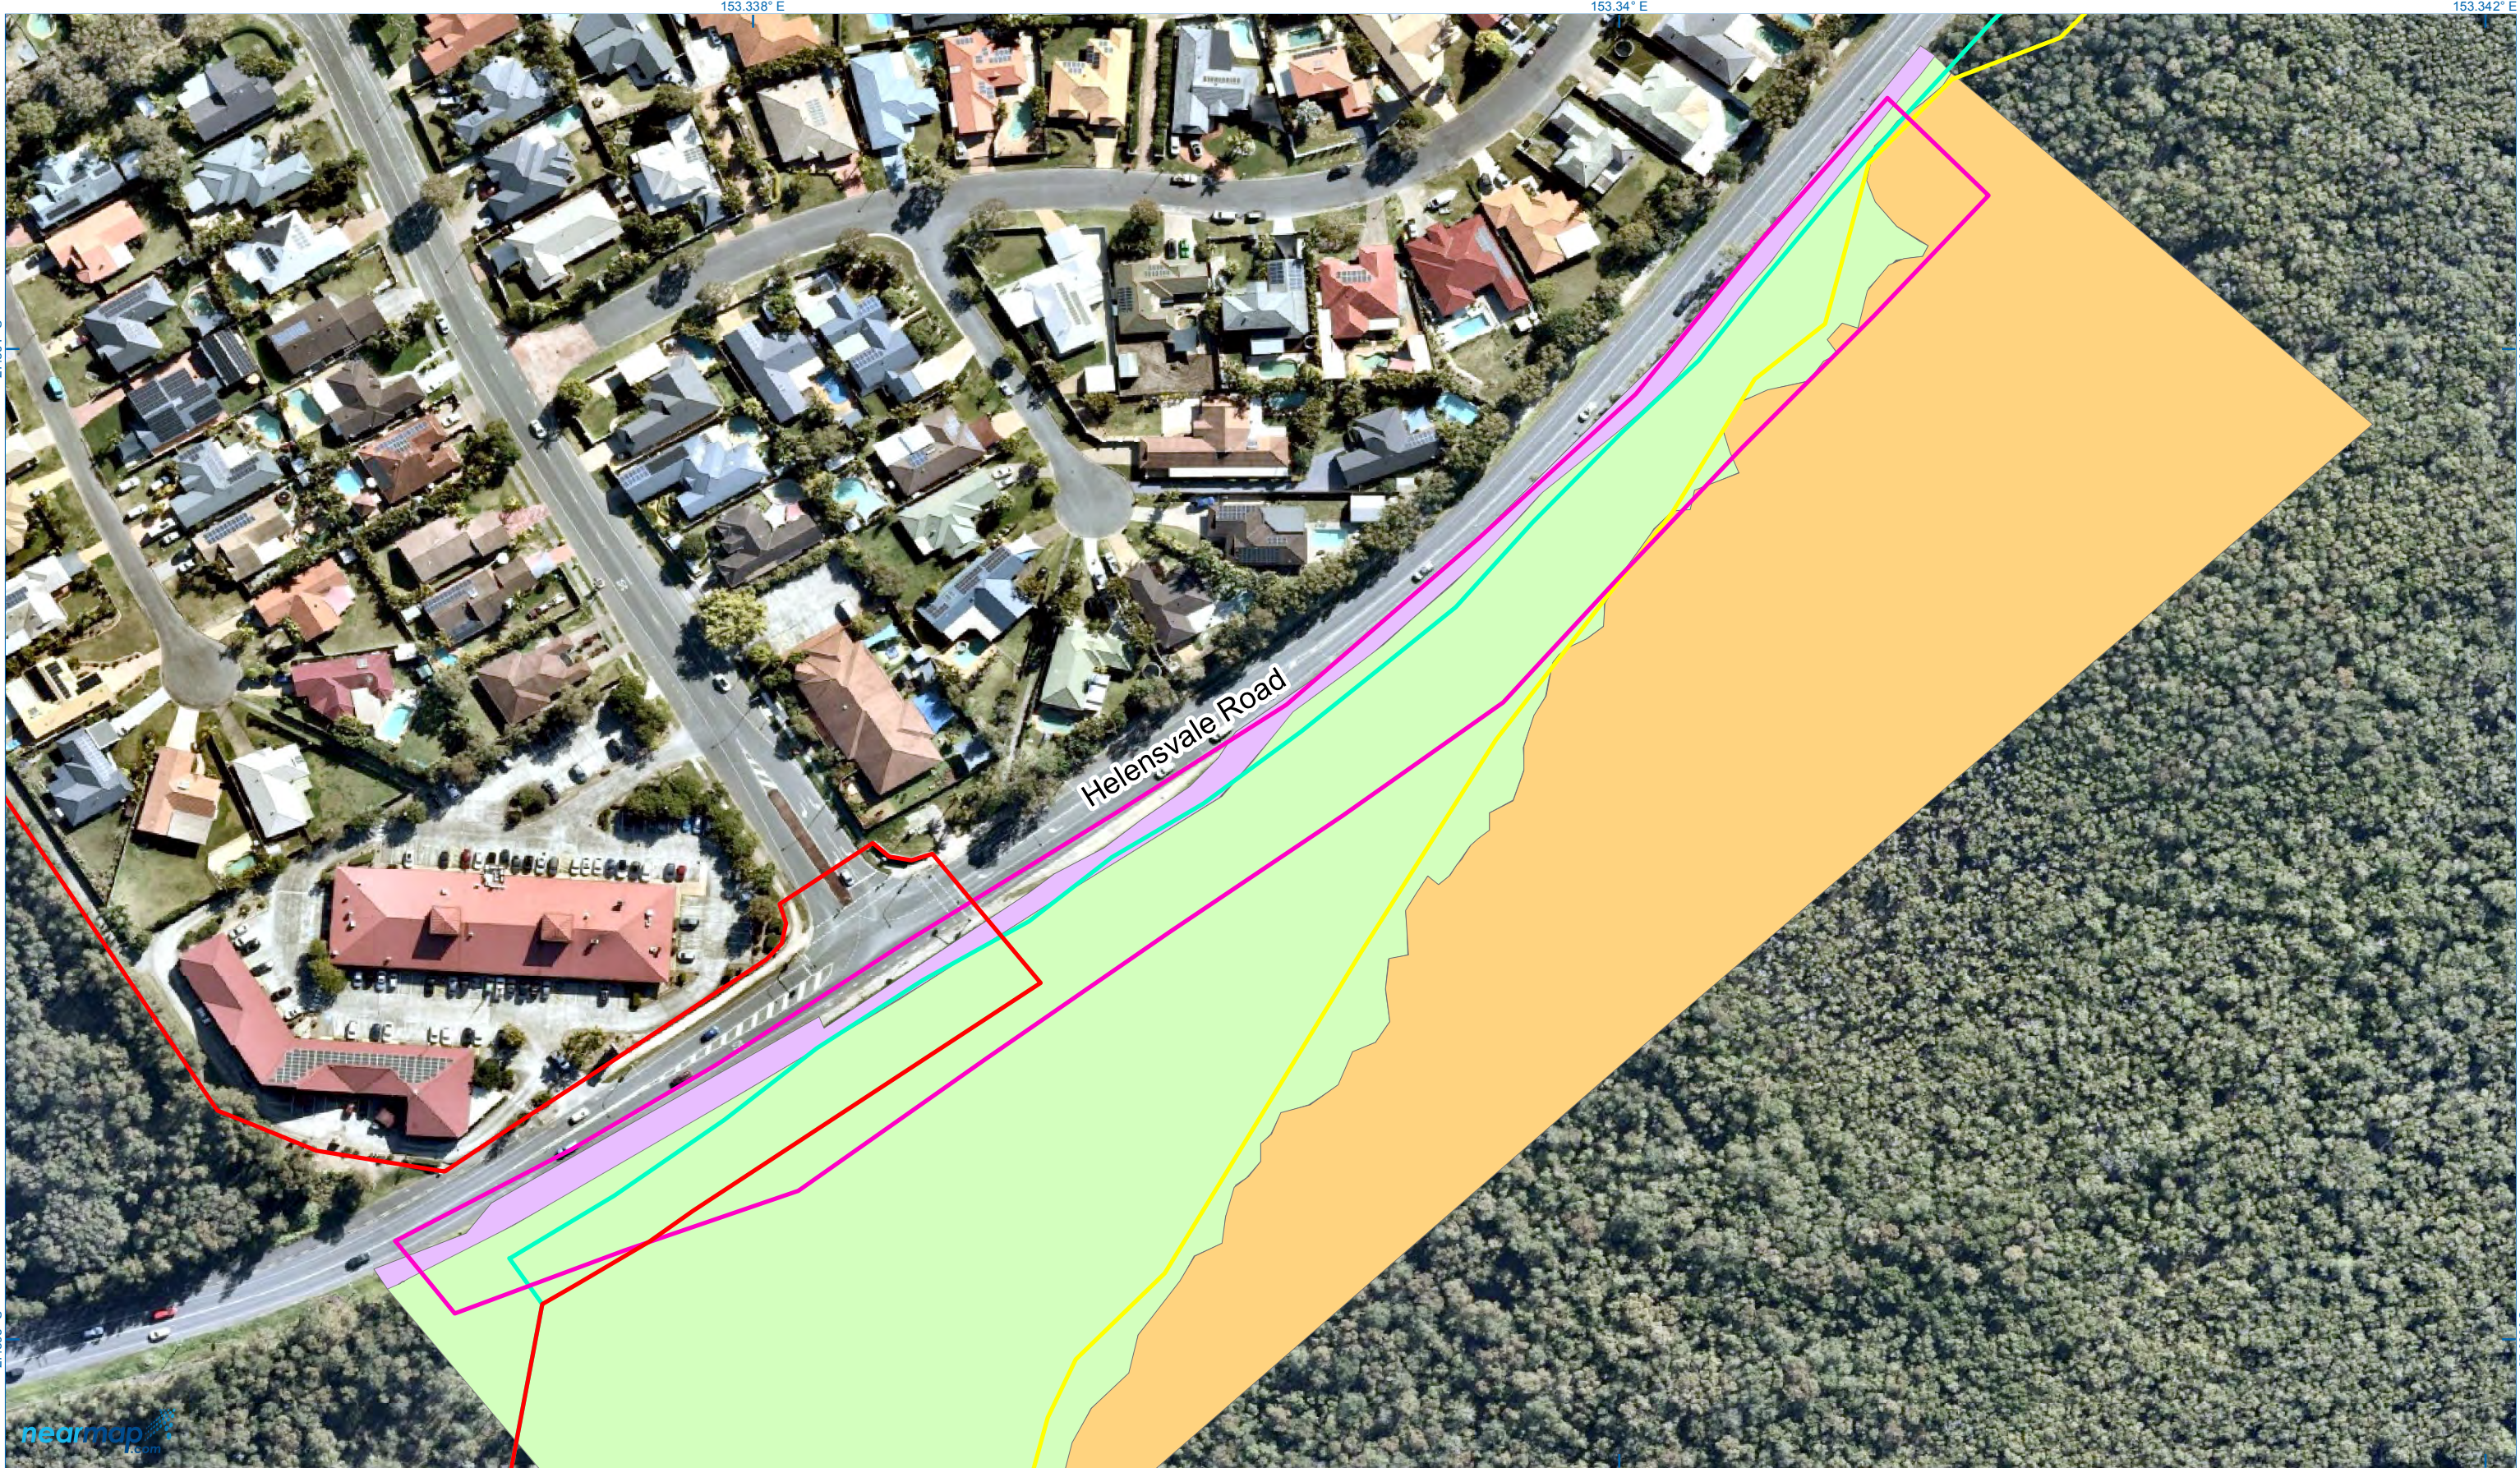
### Map 2: Vegetation and Marine Plant Communities

There were three dominant vegetation communities on the Site (Map 2):

The *Casuarina glauca* community dominated the Site, and extended from the fence line adjacent to Helensvale Rd towards the lake. Between the road and the fence line there was a mown grass verge, and in wetter areas towards the Coombabah Lake, vegetation was dominated by mangroves.
